VOLVO OCEAN RACE INDEPENDENT REPORT INTO OCEAN RACING AT NIGHT IN AREAS OF HIGH VESSEL TRAFFIC DENSITY

The Volvo High Traffic Density Report

Chris Oxenbould, Stan Honey and Chuck Hawley
17 September 2018

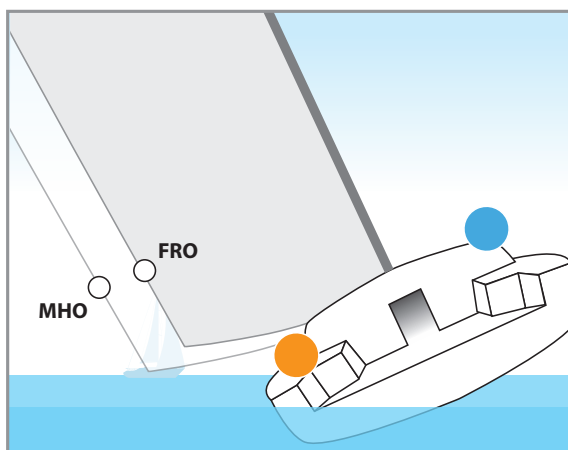
Figure 8 -Depiction of the look-out from the cockpit - Blue dot the Helmsman - Orange dot the leeward lookout - Different arcs of visibility with MHO and FRO

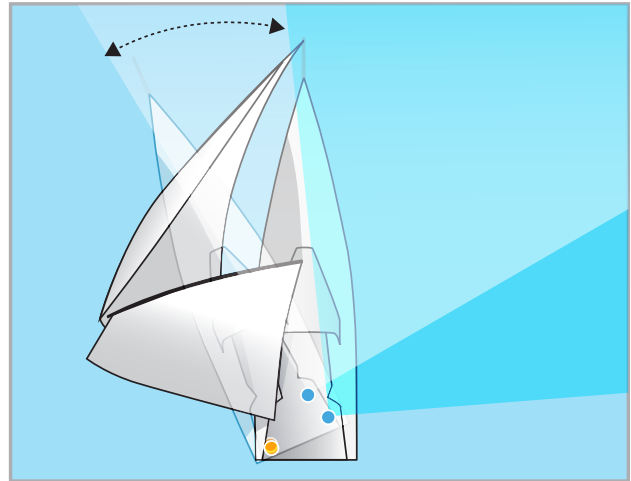
Figure 11 - 'Dipping' the bow to leeward by 20° demonstrating the increased look-out to leeward available to the helmsman

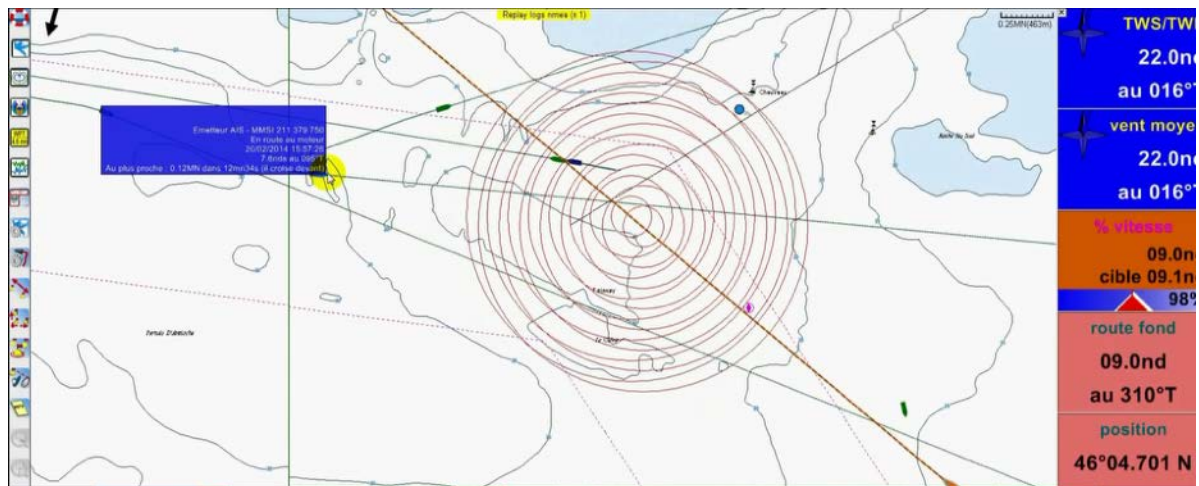
Figure 12 - Adrena presentation - the Blue text box (top left) includes - At the nearest 0.12nm in 12 min 34 sec (he crosses ahead) - the CPA information

92. When interviewing the crews, the Adrena AIS interface was reported as easier to use than Expedition. Adrena's AIS display specifies whether the closest point of approach (CPA) has the other vessel passing ahead or astern of your own vessel. This provides a simple interpretation of which way to turn to increase the CPA. Adrena's AIS display was reported to become complicated and difficult to use in dense traffic environments.

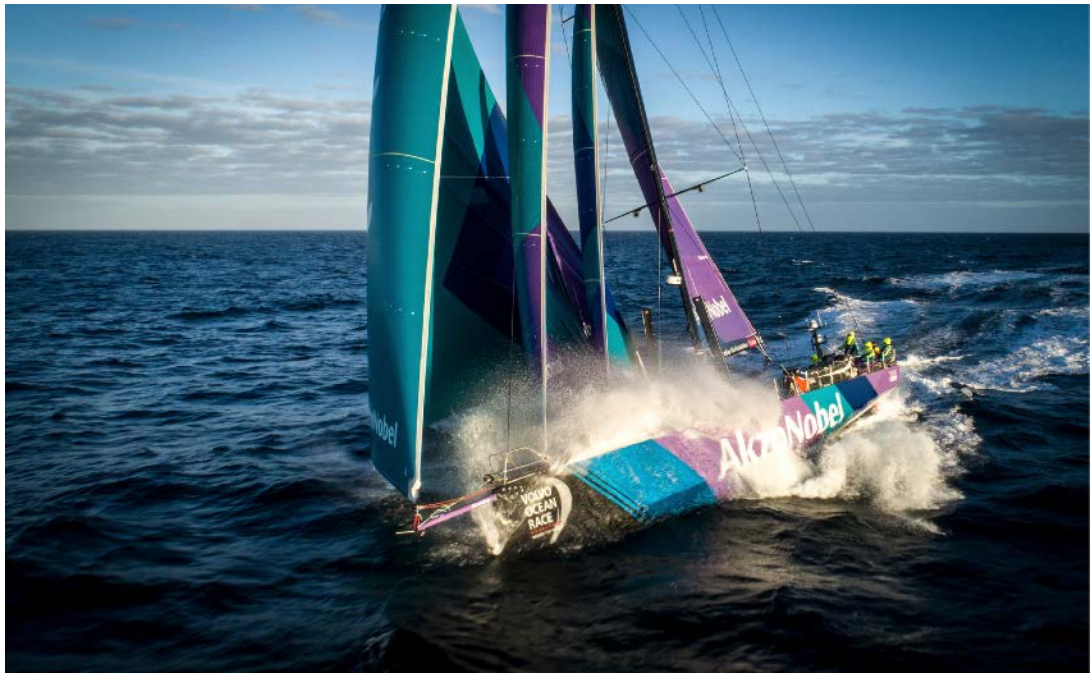
101. The radar antenna is sited on the forward face of the mast at a height of about 6 metres, which is below the first spreaders. The signal is attenuated and the receiver noise floor is increased by the loss and reflection from the headsails. This is more pronounced when the sails are wet and results in poor radar coverage in the critical area of the lee bow where the visual look-out is also degraded. Radar detections often follow an initial visual sighting.

Figure 14- Akzonobel with the radar antenna visible on the mast just above the top of the daggerboards - the steaming light can be seen on the mast just above the spreaders

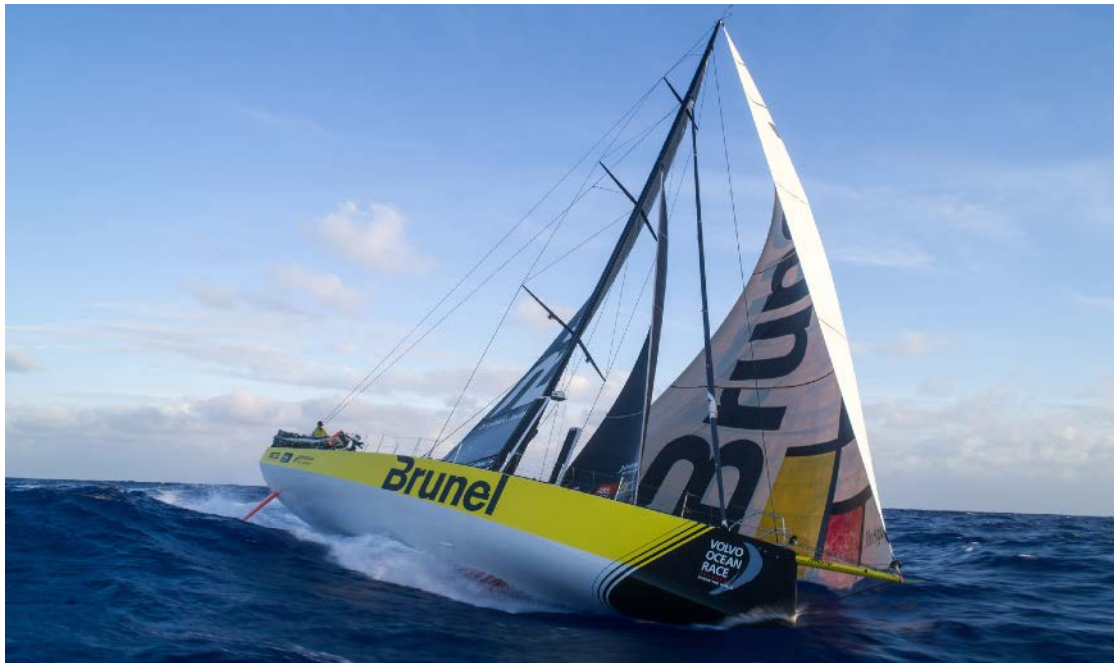
Figure 16 - The problem the look-out on the lee bow
Credit: Sam Greenfield/Volvo Ocean Race

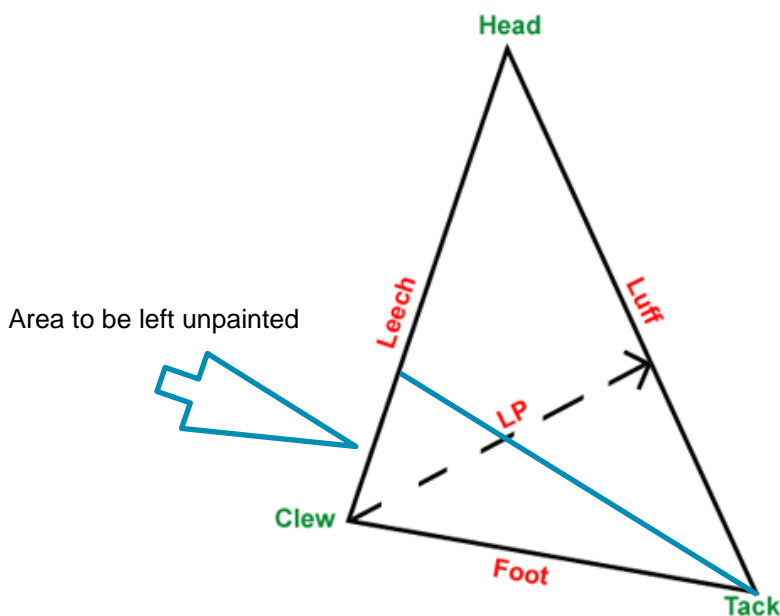
178. In an attempt to resolve the look-out blanking problem created by the headsails, suggestions were received proposing clear panels being placed in the headsails as are often used in other classes that have a similar look-out problem.

Figure 22 - Named parts of a headsail - with the marked area considered to be left unpainted

179. At present all of the sails with the exception of the A3 are painted with a selection of base colours that are then used as a background for the Volvo and other sponsor signage. When this process is complete the sails are opaque and it is not possible to see any light through them. A variation of the clear panels was also suggested, proposing a large triangular section on the foot of the sail be left unpainted, clear of any signage and possibly translucent. The triangle would have a corner at the tack

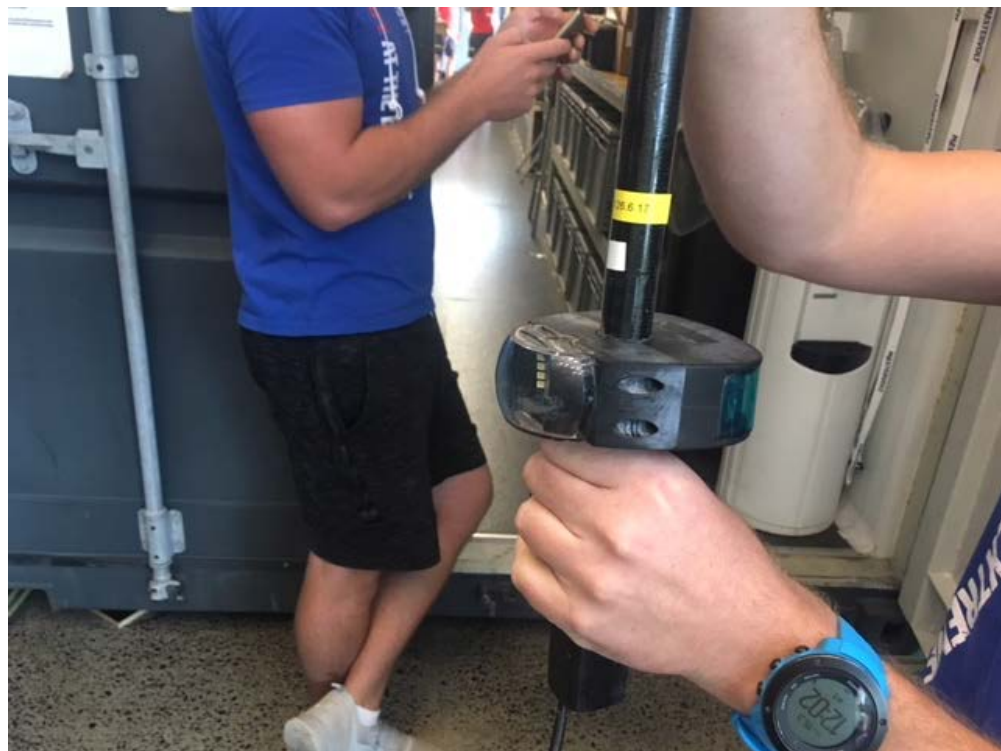
190. The three lights fitted at the masthead are separate Hella light fixtures with their own LED globes. They differ from the 'combined into one lantern' that is permitted in IRLCAS Rule 25 but restricted to a sailing vessel of less than 20m in length. The combined lantern is assumed to have been a means of minimising power consumption

Figure 23 - VO 65 Navigation Light fitting clamped on to the vertical masthead unit that is fitted to the top of the mast - viewed from the starboard quarter, showing the sternlight and starboard sidelight

208. The report team considers that VO 65s should be fitted with a second set of sidelights and a sternlight near deck level to enhance the presence of the boat at night in areas of high vessel traffic density and in harbour. The additional lights could be used, at the discretion of the PIC, in conjunction with the lights at the masthead, whenever warranted by the prevailing circumstances.
