Department of  
Transport

## Investigation Report Capsize of the yacht 'Finistere' on 24 February 2018.

Prepared for Department of Transport

Date 12/11/2018

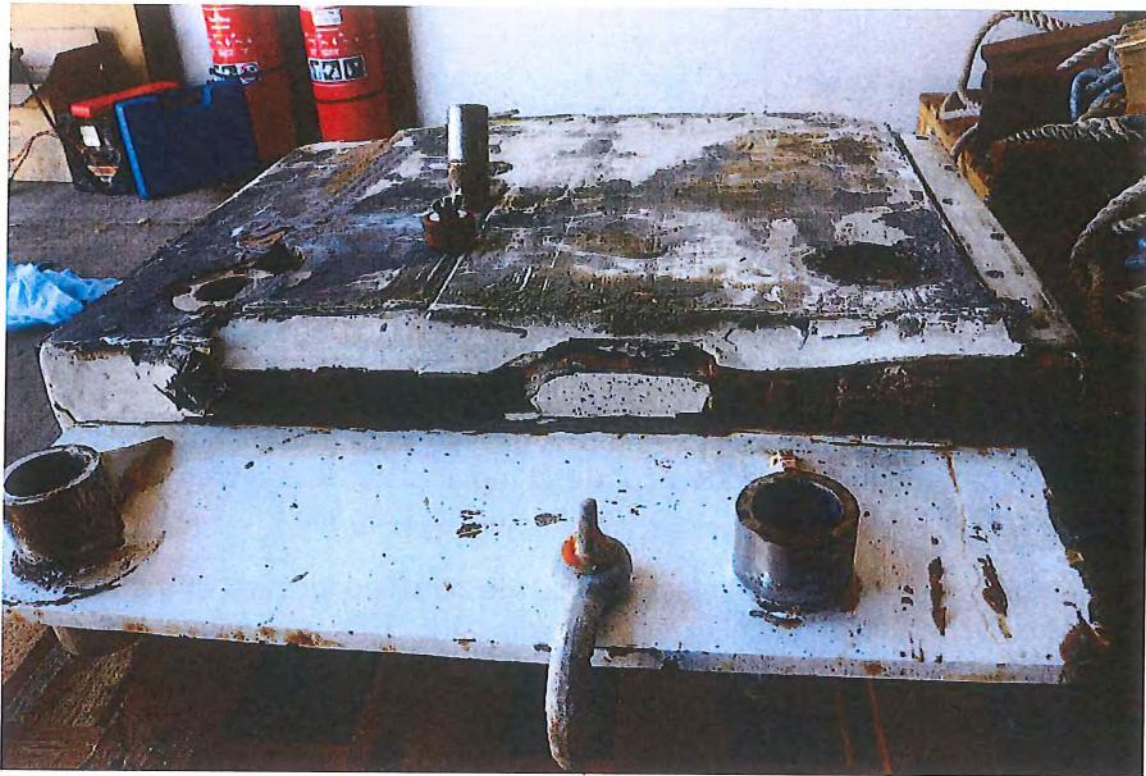
*Image 10, shows externally visible damage to the port side of the keel. The wooden core has dropped, and the anti-gravity pin has been pulled through to the port side. Deconstruction would later confirm that extensive de-lamination (of the wooden core, steel/epoxy interface, through keel fittings and external keel skin) had occurred causing the port side skin to slip.*

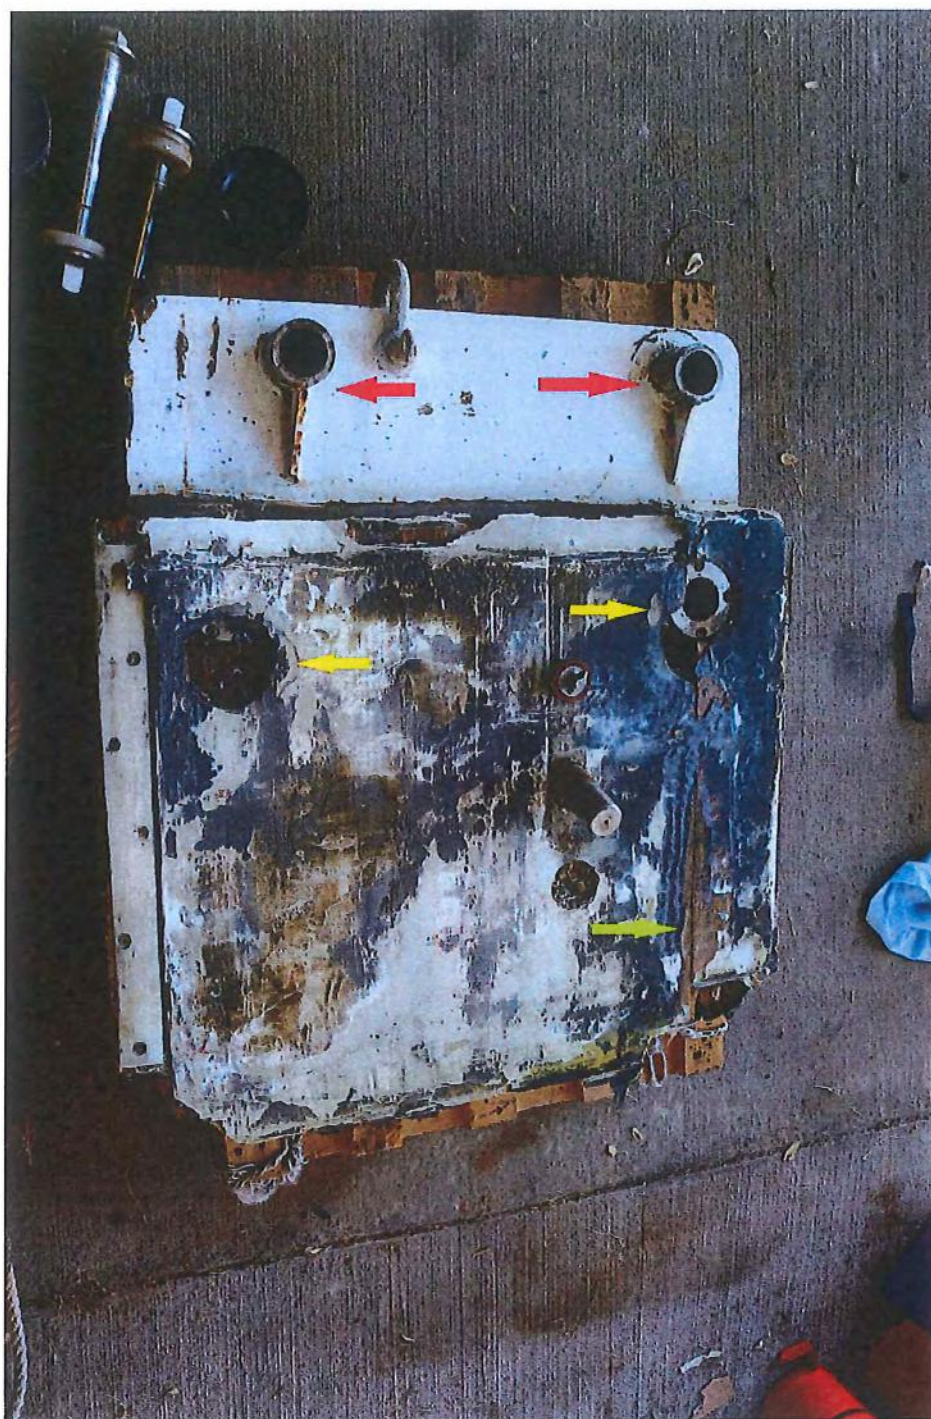
Image 11, Remaining portion of keel prior to deconstruction (port side view).

The original holes through which the keel locking pins passed were present and consisted of a metal sleeve that went through the wooden core and metal plate. It was also noted that the position of the anti-gravity pin had been raised and the original hole filled.

Red arrow – Steel plate keel modification and new location for keel pins.

Green arrow - Area of abrasion showing worn carbon fibre and exposed wooden core.

Note: The steel pin exiting the keel is the anti-gravity pin. The hole below it was its original position.

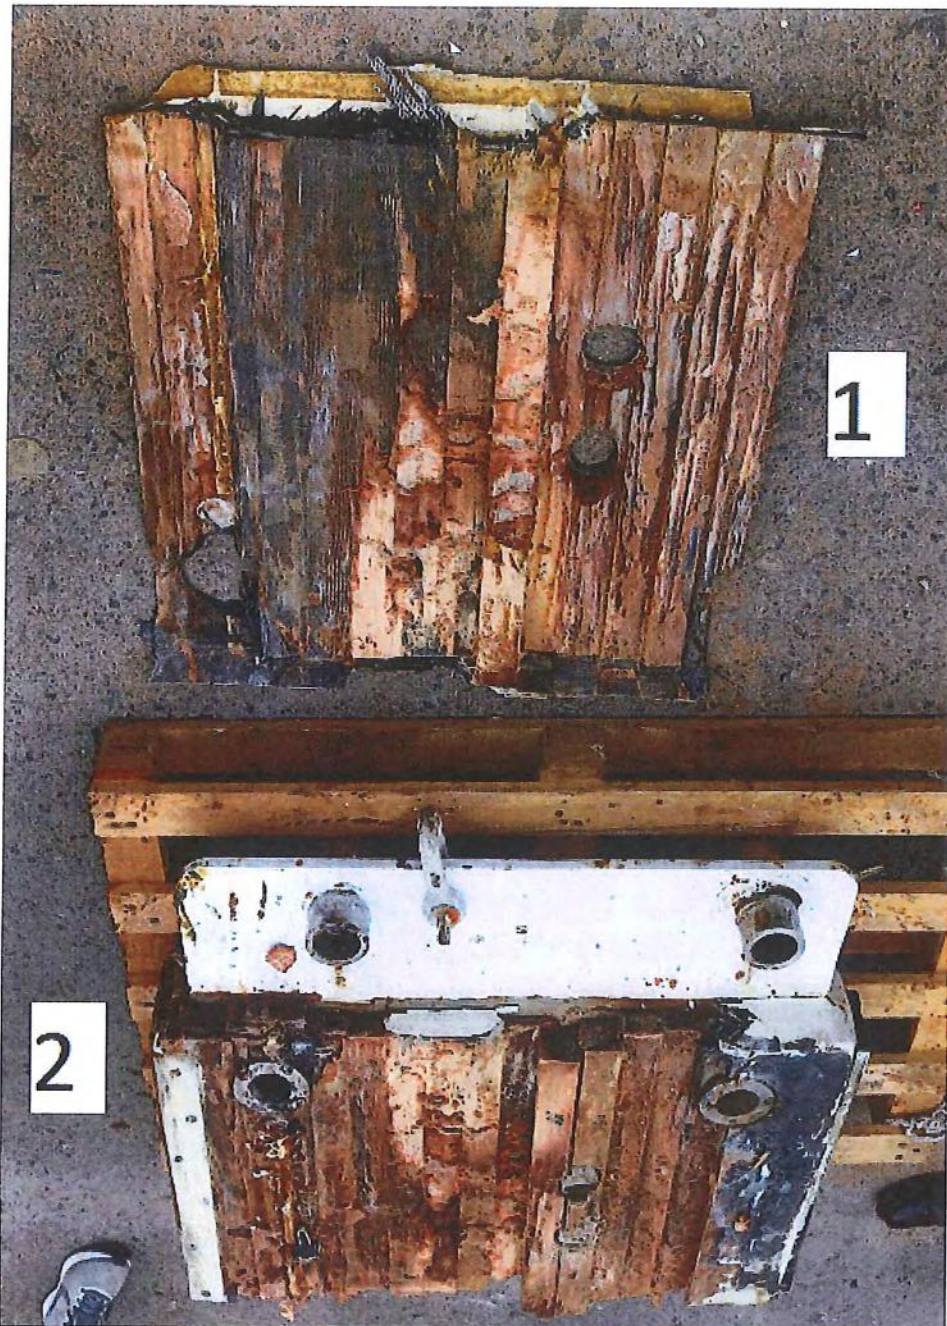
Image 12.

- 1 – Skin, carbon laminate and part of the wood core as lifted from the port side of the keel.
- 2- Port side of keel with section one removed.

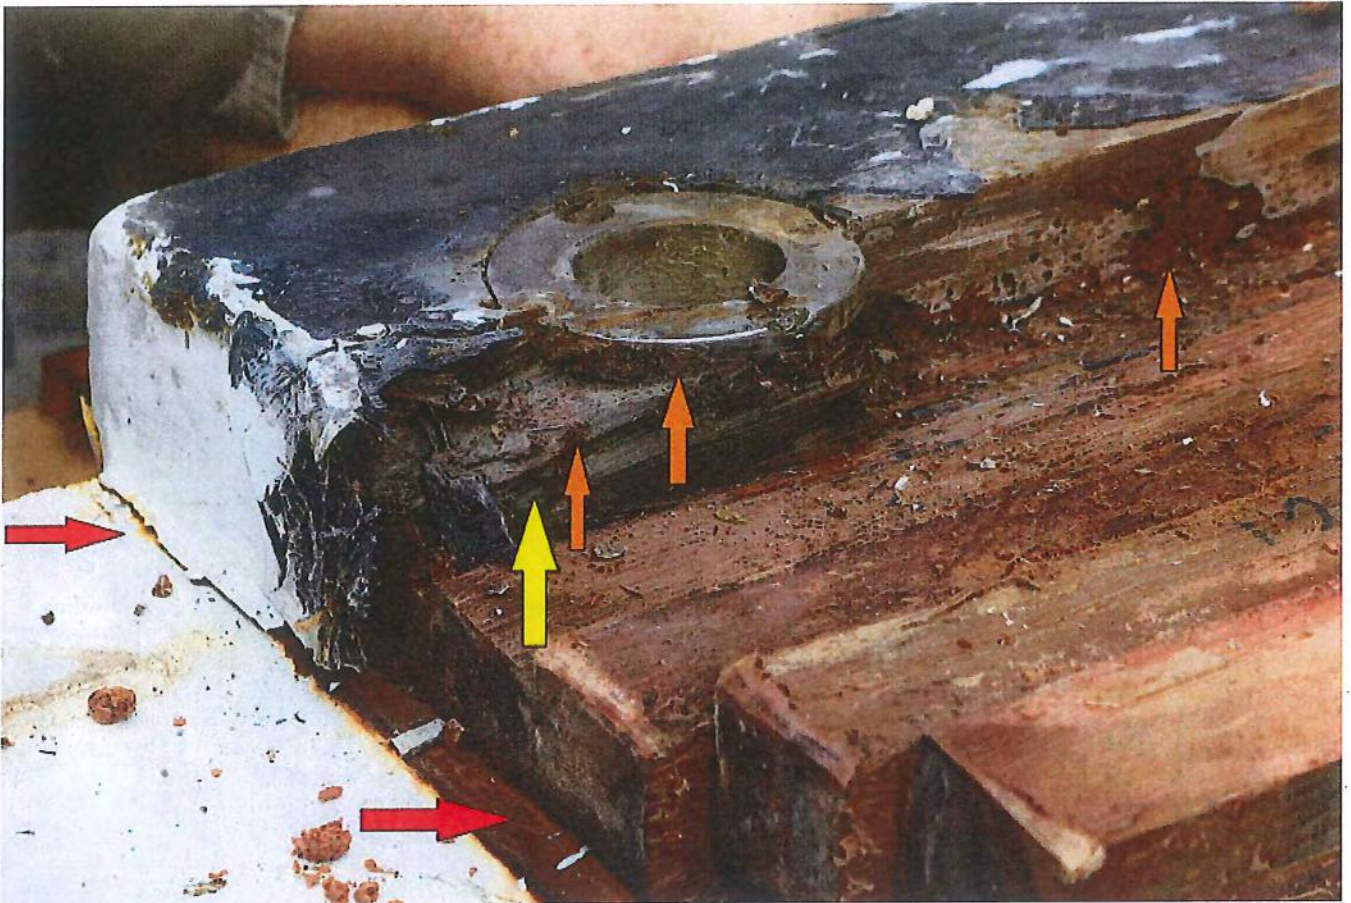
Image 12, Keel deconstruction.

Red arrow – delamination between steel plate modification, epoxy sheath and outer casing.  
Yellow arrow – waterlogged wooden core.  
Orange arrow – areas of rotten timber.

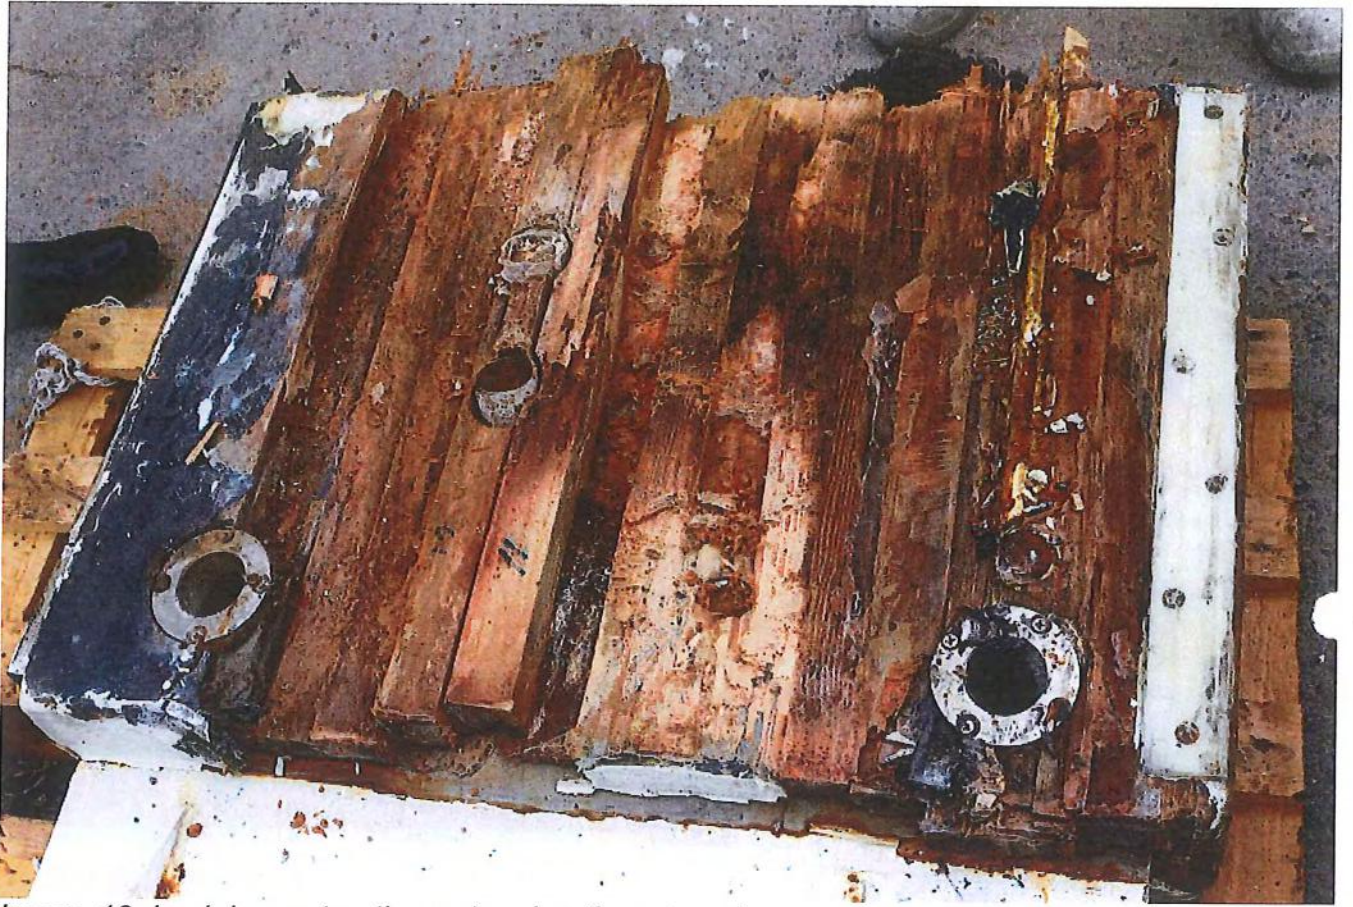
*Image 13, keel deconstruction outer sheath removed.*

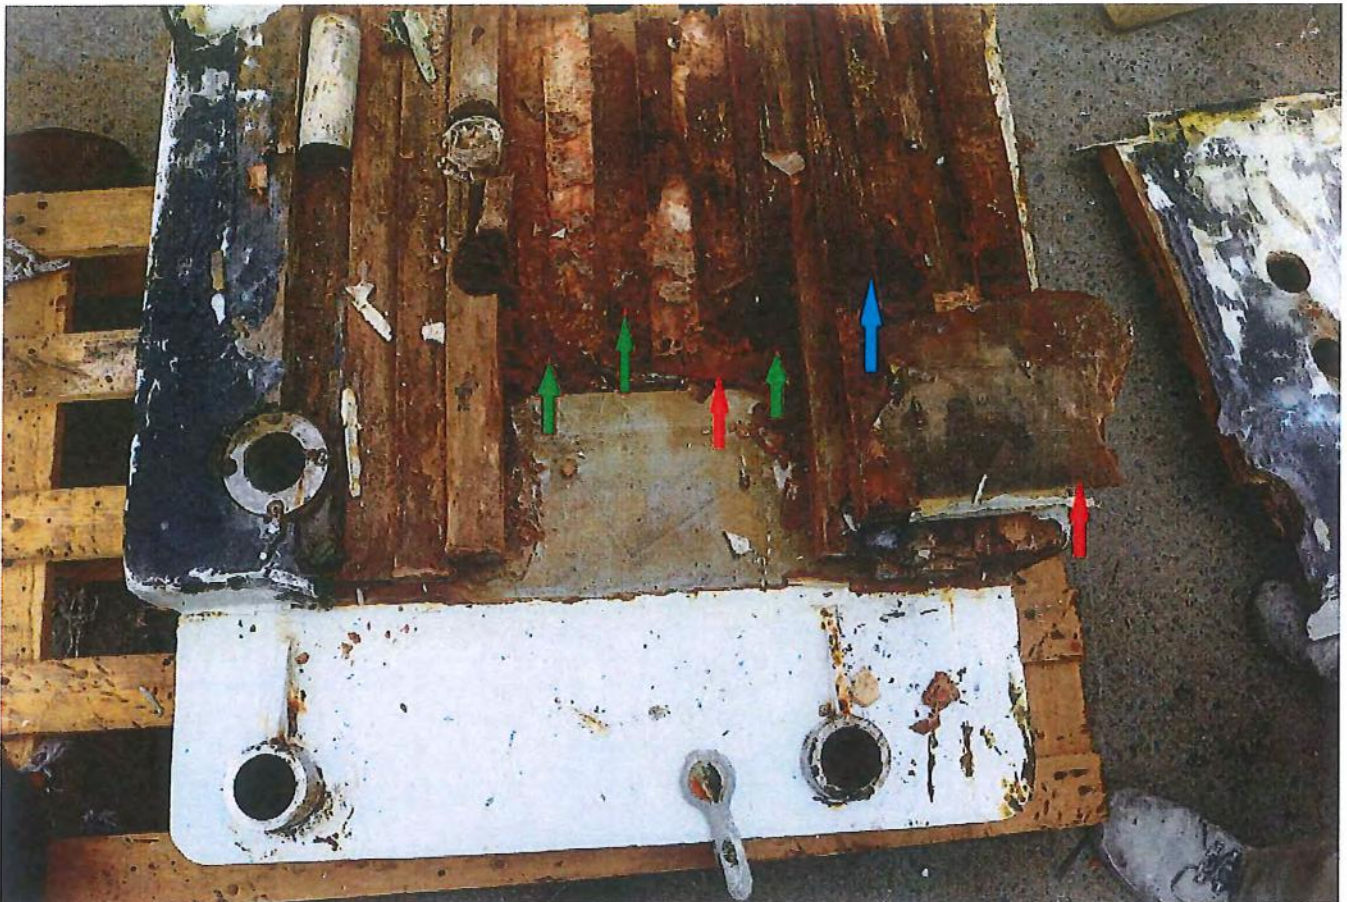
*Image 14, Keel deconstruction central wood layer and epoxy sheath around steel plate lifted.*

*Green – waterlogged and rotting timber.*

*Blue – Section of epoxy sheath and timber removed to expose central area of keel core, and steel plate.*

*The epoxy resin has not adhered to the steel plate (Image 14), instead lifting away with the wooden core (to which it was securely bonded). This is indicative of an adhesive failure at the epoxy/metal interface due to the shearing forces to which it was subjected.*

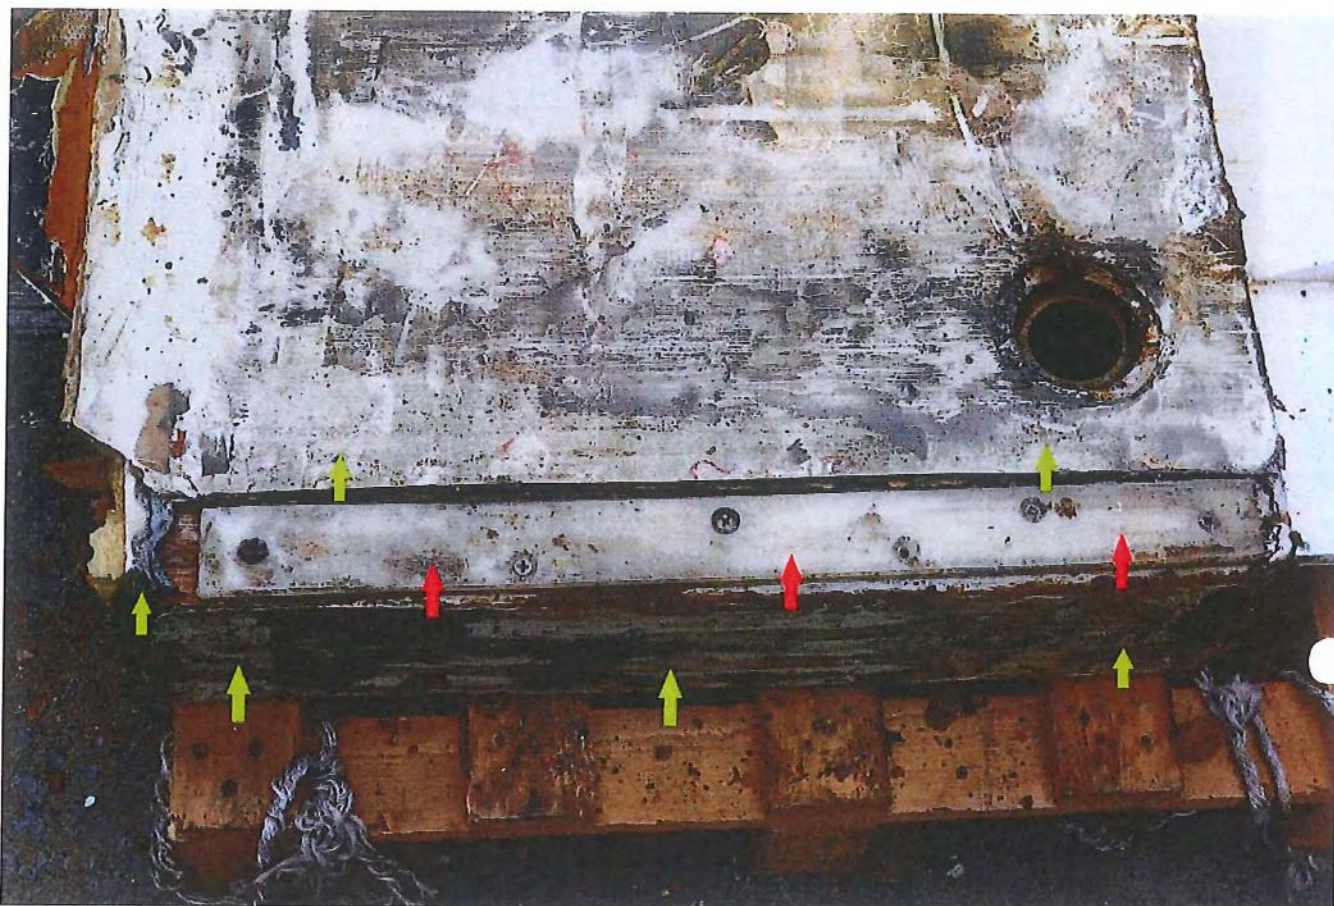
*Image 15, Nylon bush on right hand side of the leading edge of the keel.*

*Nylon bush – red*

*Noticeably in Image 15 the carbon fibre sheath was absent underneath the nylon bush. Therefore, the carbon fibre sheath did not extend around the entire core on the portion of the keel contained within the keel case. An outer skin cover laminate consisting of carbon fibre and epoxy, encasing the entire keel, is noted on the plans.<sup>23</sup>*

Additionally, ensuring that any intrusions through the keel's skin are watertight is critical to maintaining its structural integrity. The absence of a waterproof skin under the nylon bush on the leading edge of the keel could be considered an error in the manufacturing process.<sup>26</sup> The presence of water ingress around through skin intrusions such as the antigravity pin and locking pin holes could be due to manufacturing errors, or the consequence of material failure caused by other factors such as groundings.

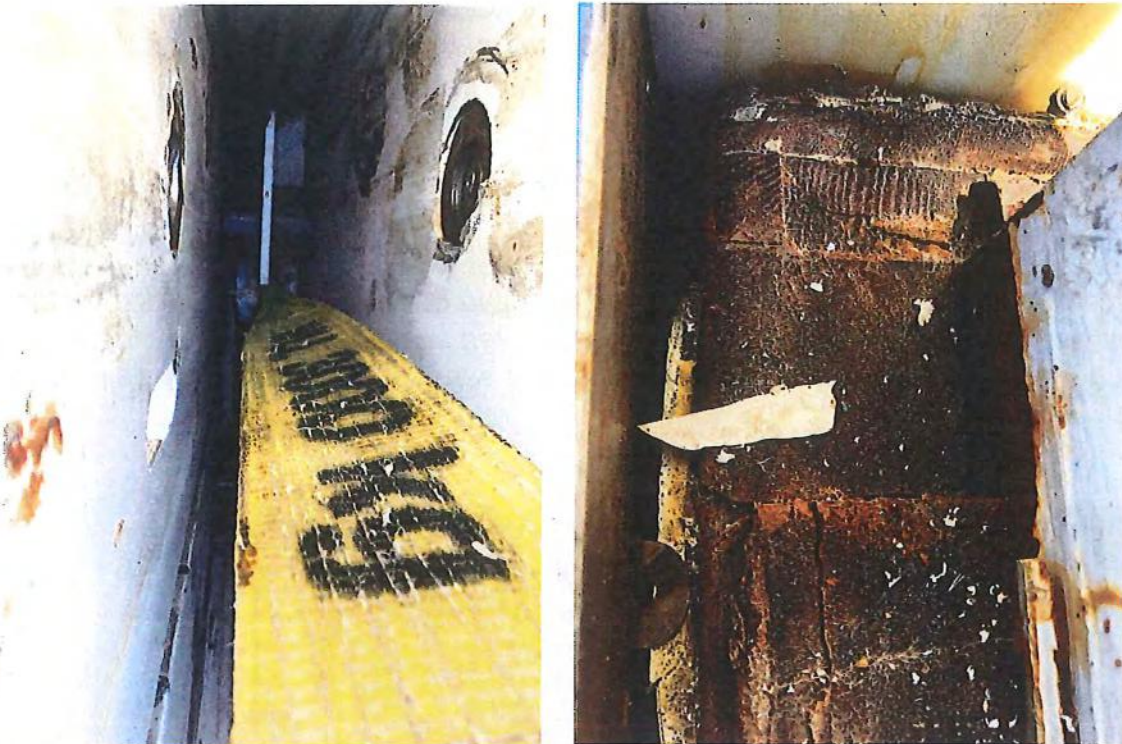
Image 16-17, Keel inside the keel box viewed from the top. note: damage is evident on the port side of the keel.

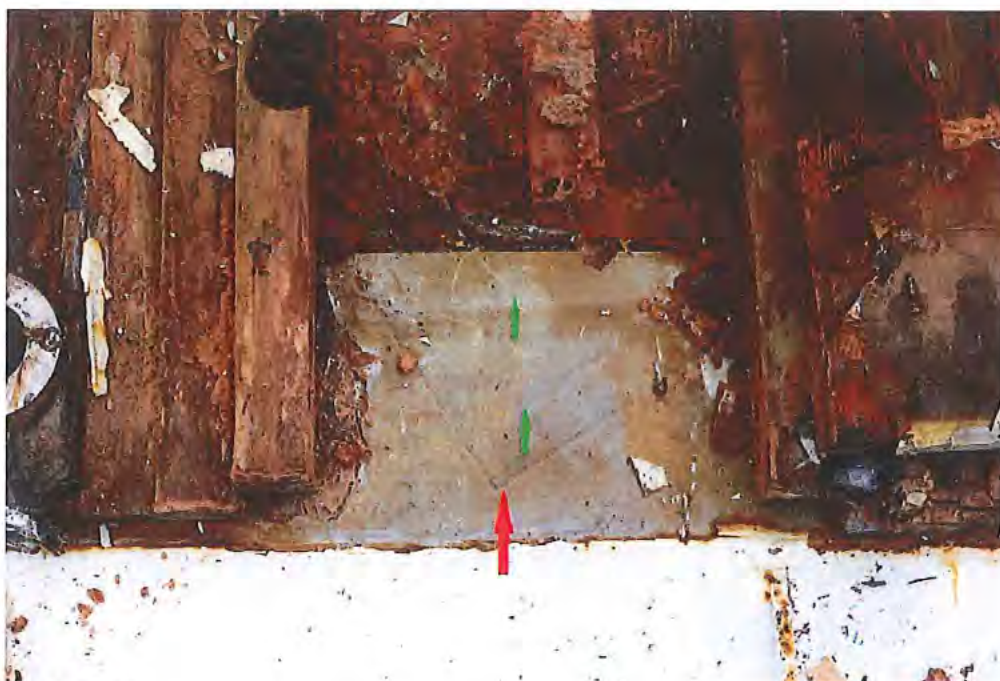
Image 16.

The surface preparation of steel is critical to ensuring that a strong bond is formed with epoxy. Ozes and Naser (2015) and Wang et al (2016). The degree of preparation undertaken [REDACTED] modified the keel is not known; however, what appears to be paint overspray on the bonded surface would suggest that it may not have been sufficient. It is also noted that a steel screw was embedded in the epoxy, and the mottled appearance of the bonded surfaces may be indicative of the presence of voids and areas of weakened bonding between the epoxy and the steel.

Red arrow – appears to be paint overspray and may indicate that the steel plate was not adequately prepared prior to being embedded in epoxy.

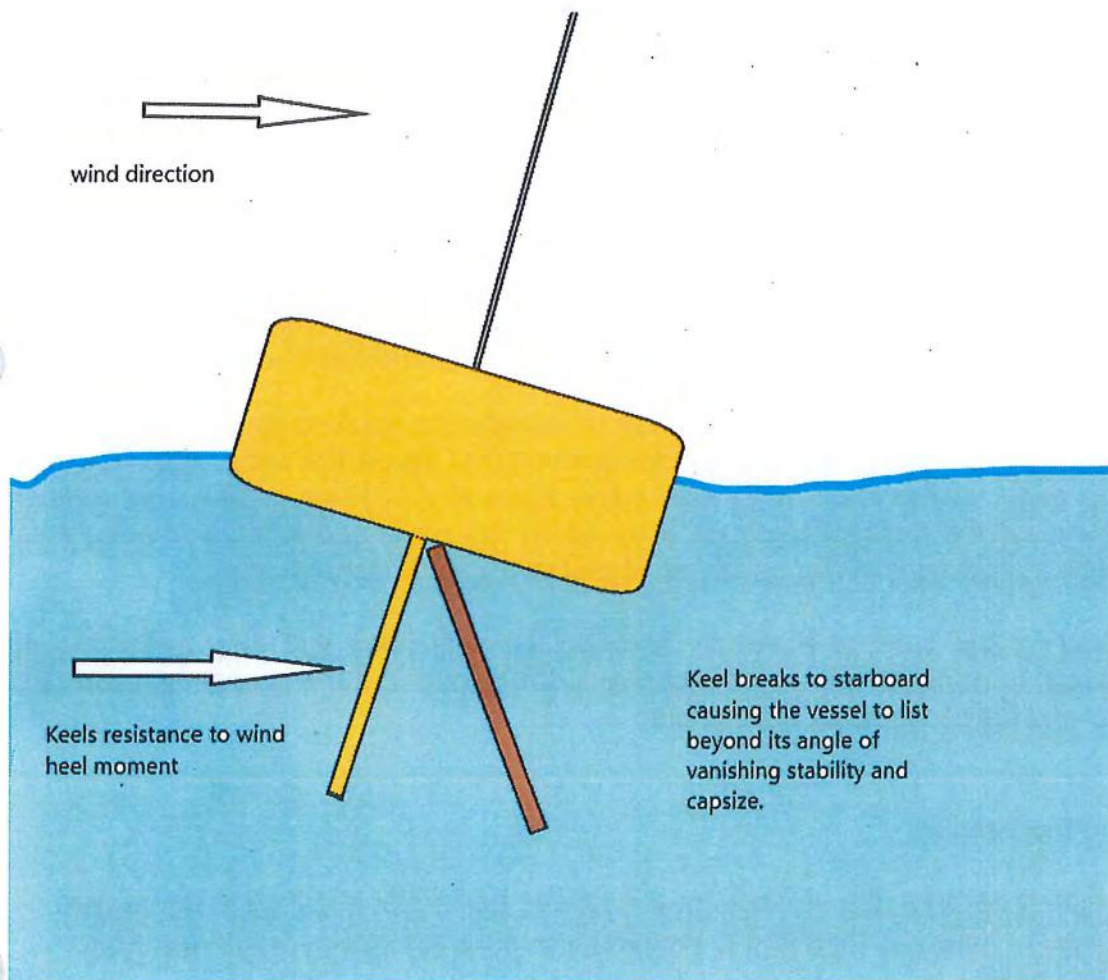
*Image 18, Shows the keels resistance to wind heel. The ballasted keel resists the heel as it tries to return the vessel to an upright position. In the case of Finistere the keel has broken away (brown) and with no resistance to wind heel the vessel capsized.*

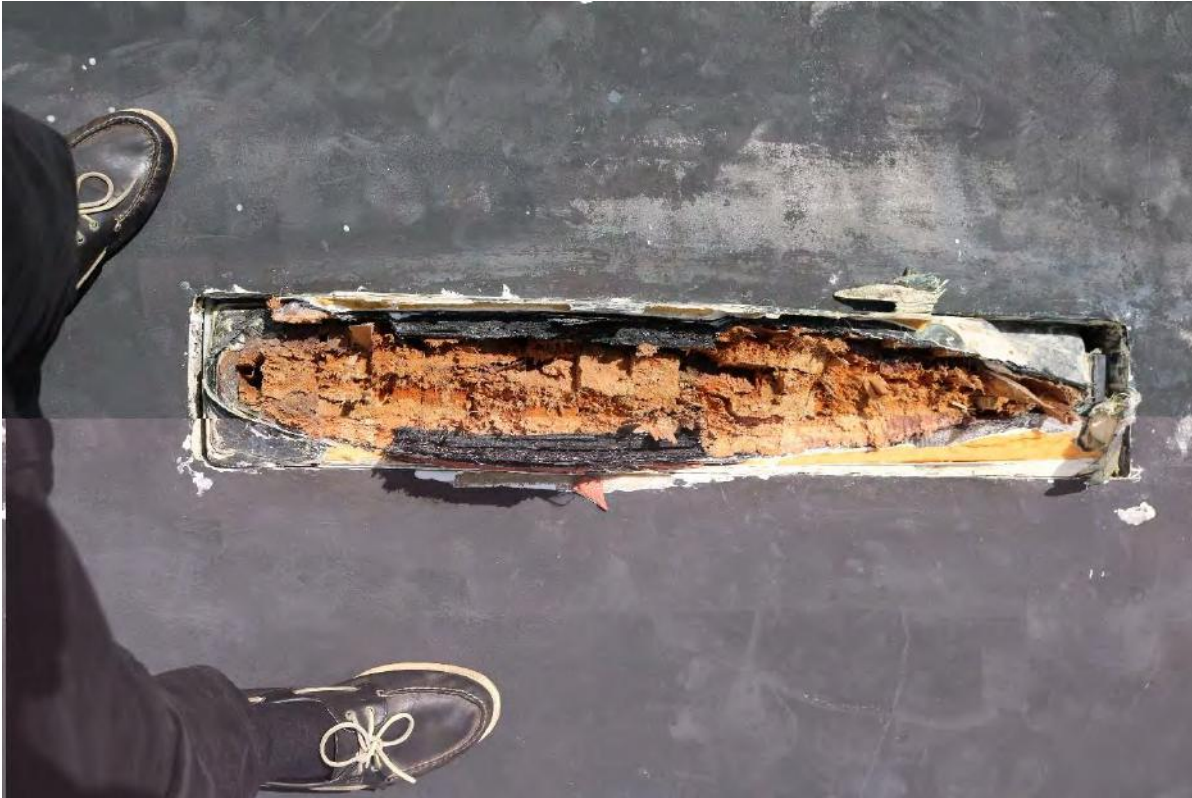
*Picture 1 - Remainder of keel flush with underside of salvaged hull.*

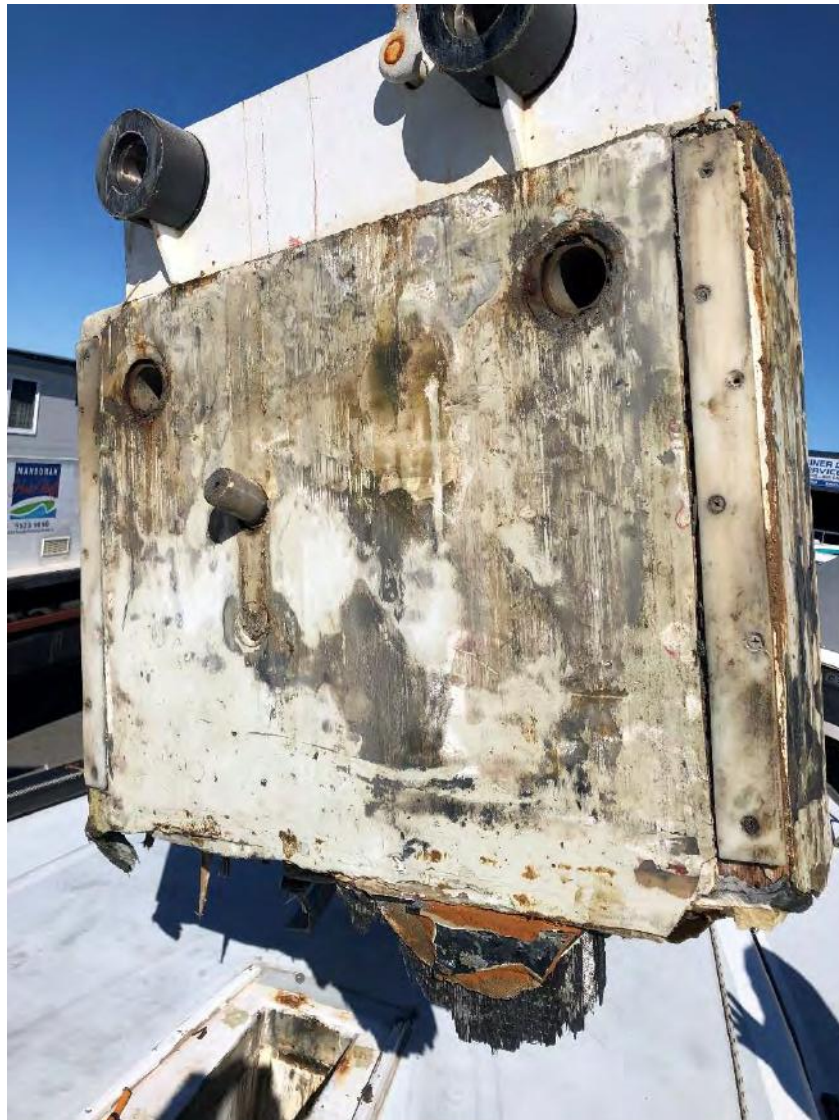
*Picture 2 - Remains of keel as extracted from hull.*

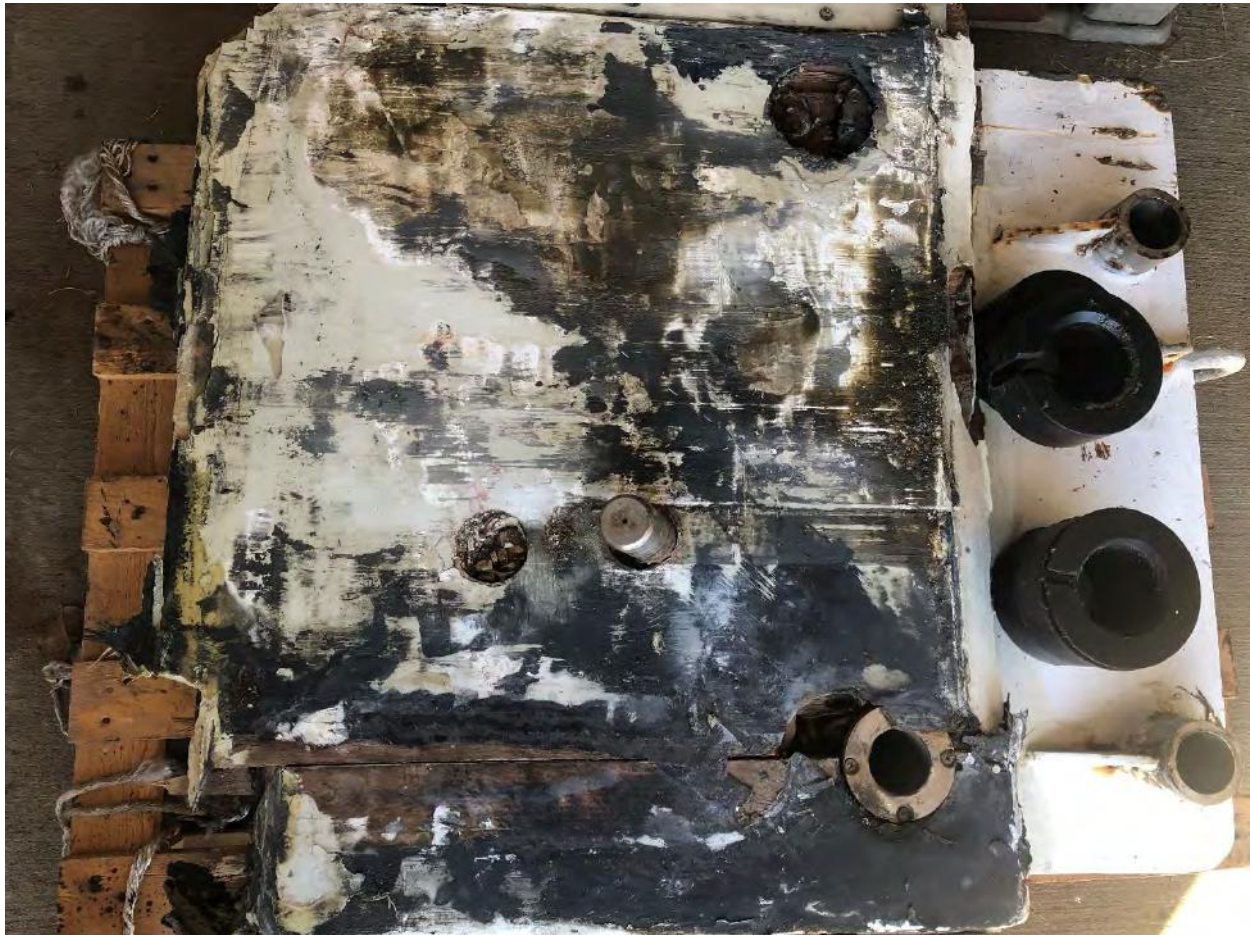
The second observation was that the outside skin on the port side of the keel appears to have moved down relative to the remainder of the keel by between 25-50mm. This movement is evident both in the resultant angle of the guide pin, and the misalignment of the locating pin holes (Picture 3).

*Picture 3 - Port skin moved down relative to remainder of keel.*

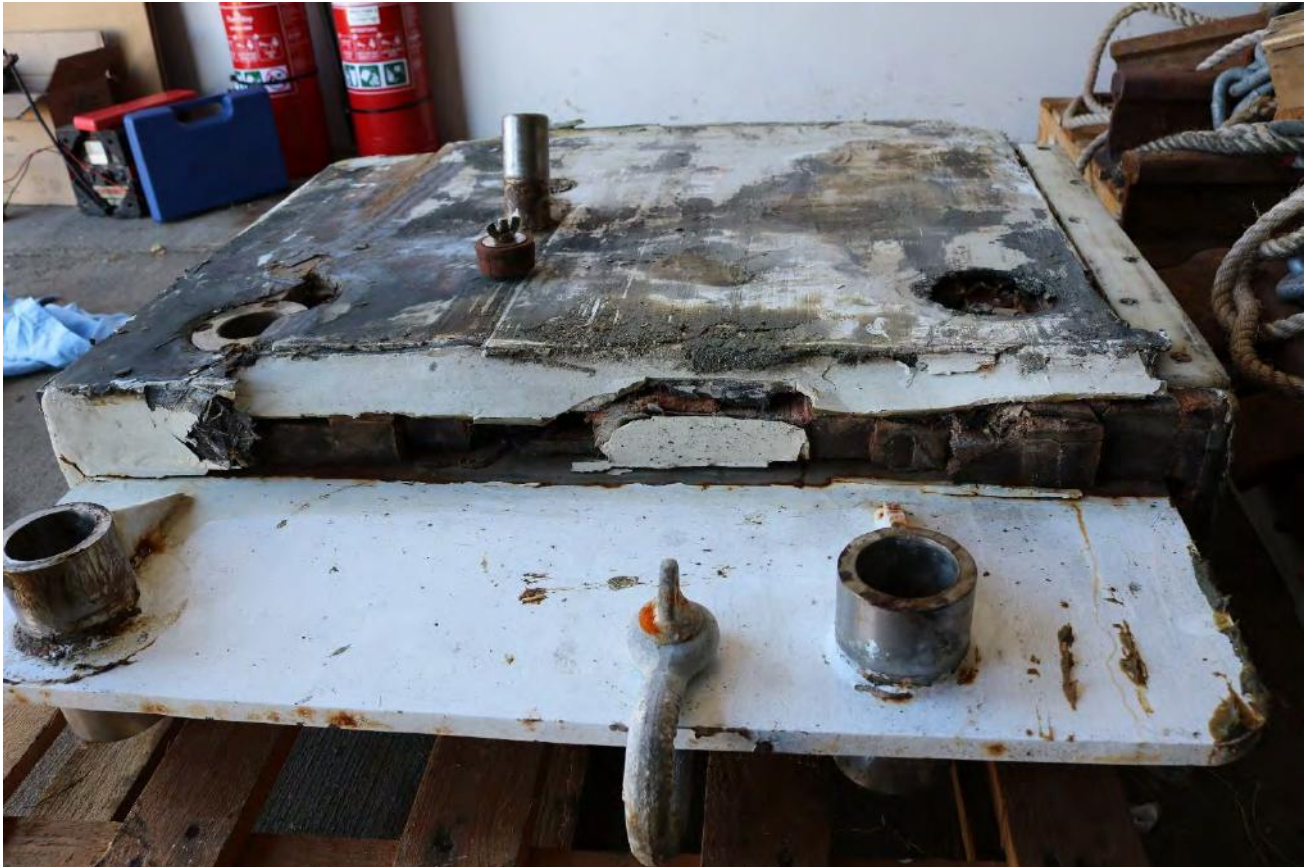
*Picture 4 – Core failed in shear, outside skin moved relative to remainder of keel.*

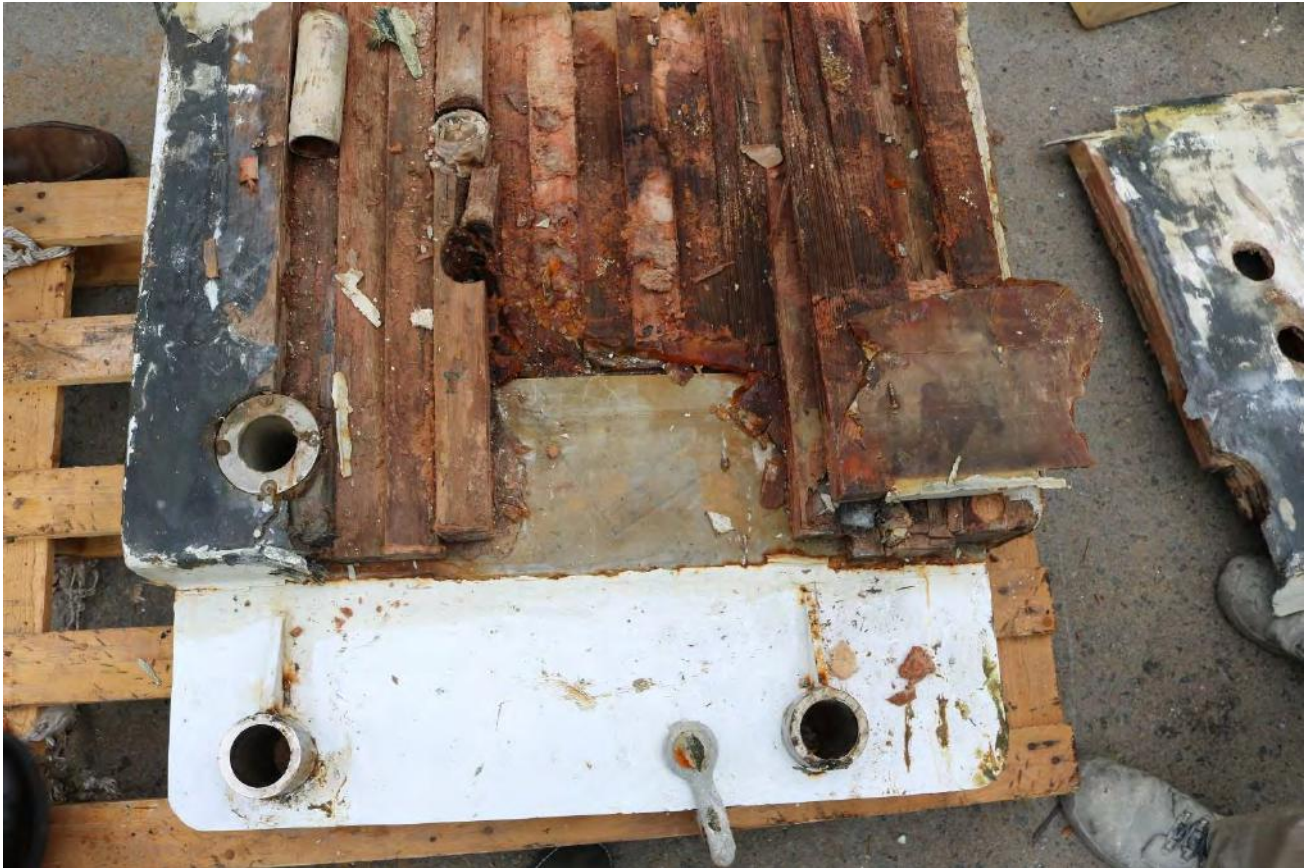
*Picture 5 – Outside skin of keel removed, evidence of water ingress and degradation of core.*

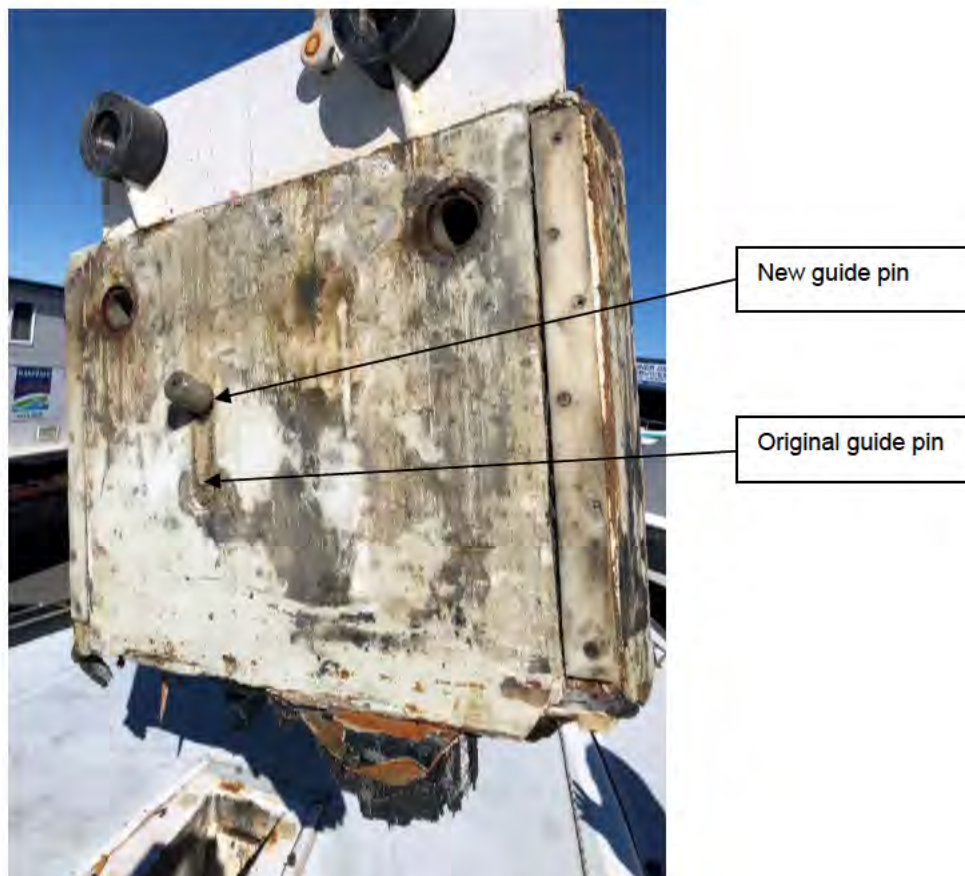
1. The location of the guide pin has been raised.

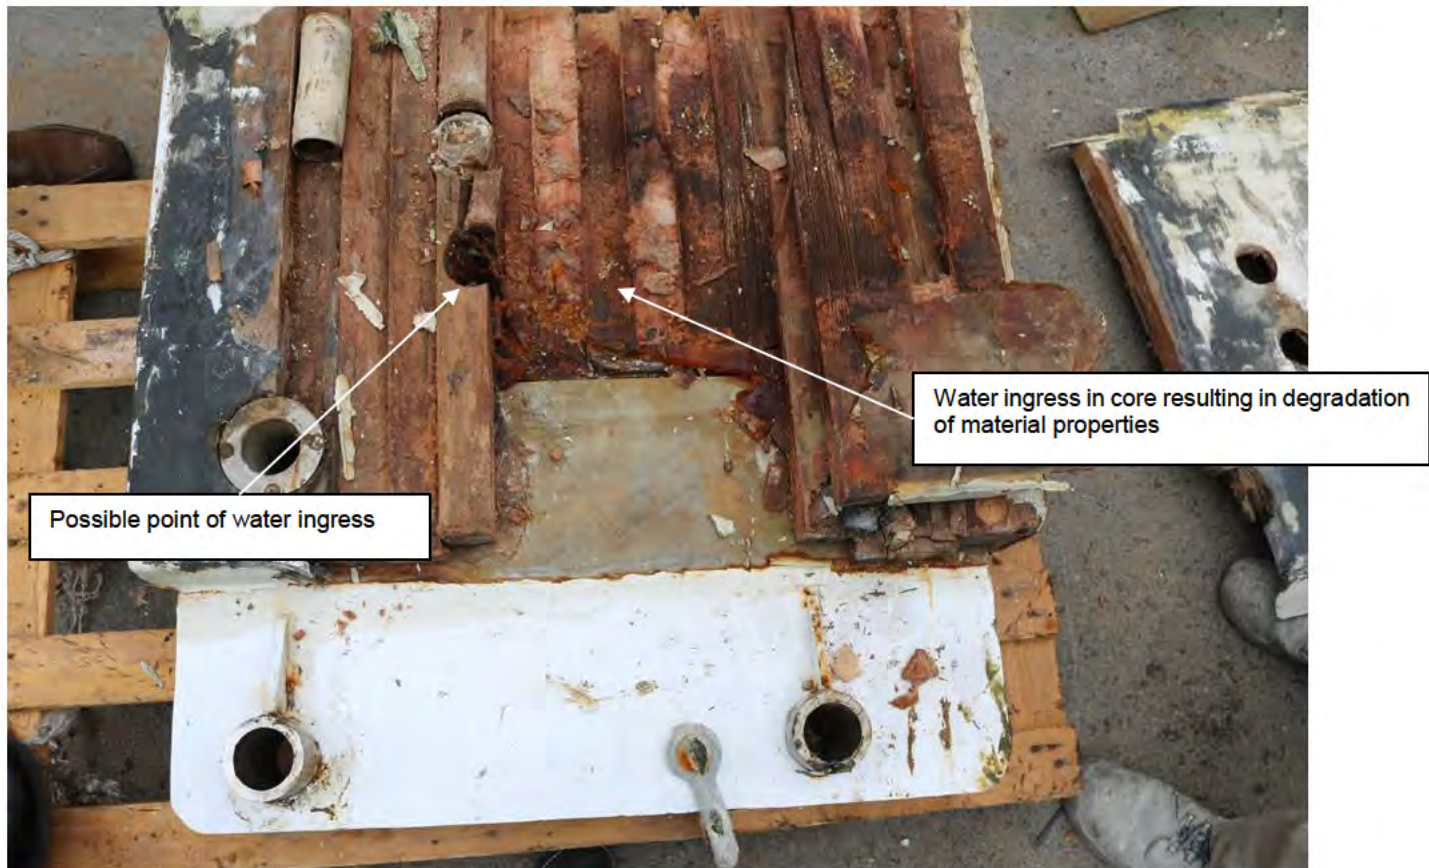
2. Water has ingressed into the keel core and degraded the material properties. It appears that the water ingress may have occurred through the hole for the relocated guide pin.

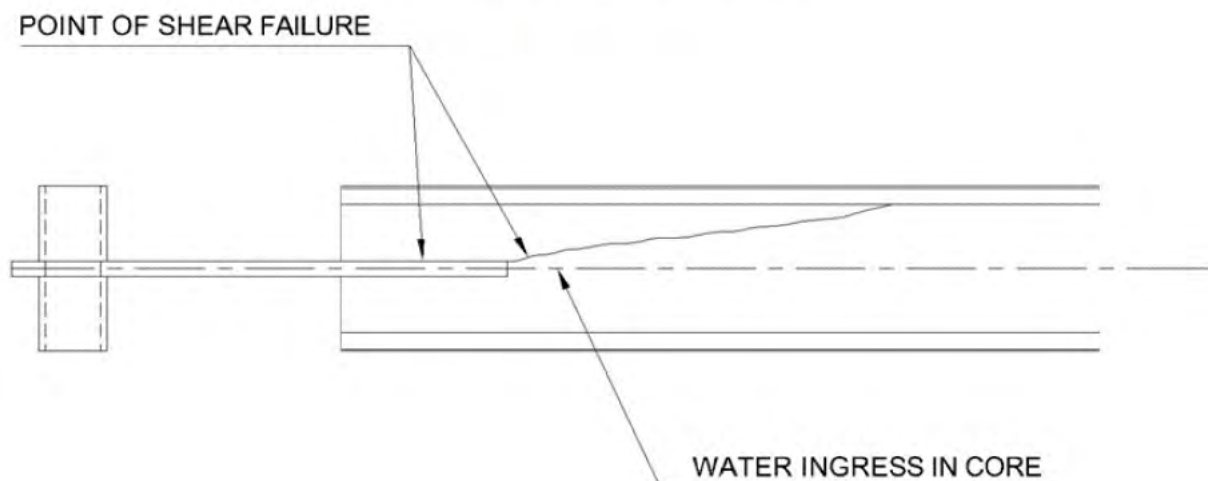
3. At the point of highest shear distribution, the timber core has begun to fail.

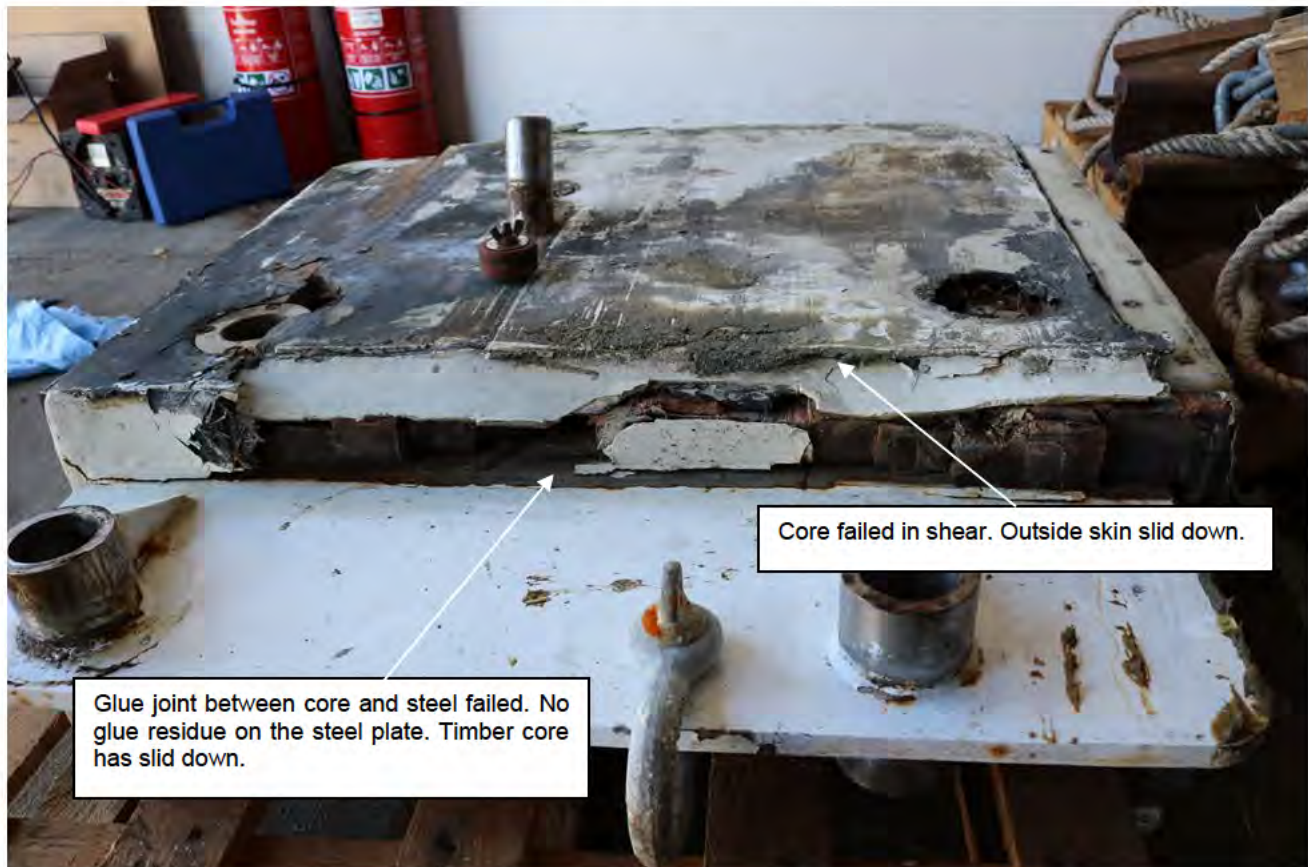
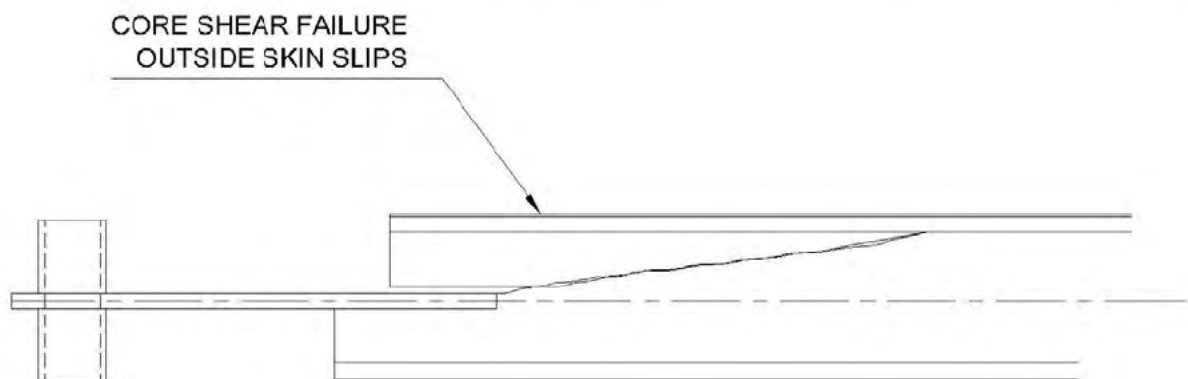
4. The glue joint between the timber core and the steel insert has failed in shear. The timber core has failed in shear below the steel insert.
