VOLVO OCEAN RACE INDEPENDENT REPORT INTO OCEAN RACING AT NIGHT IN AREAS OF HIGH VESSEL TRAFFIC DENSITY

The Volvo High Traffic Density Report

Chris Oxenbould, Stan Honey and Chuck Hawley
17 September 2018

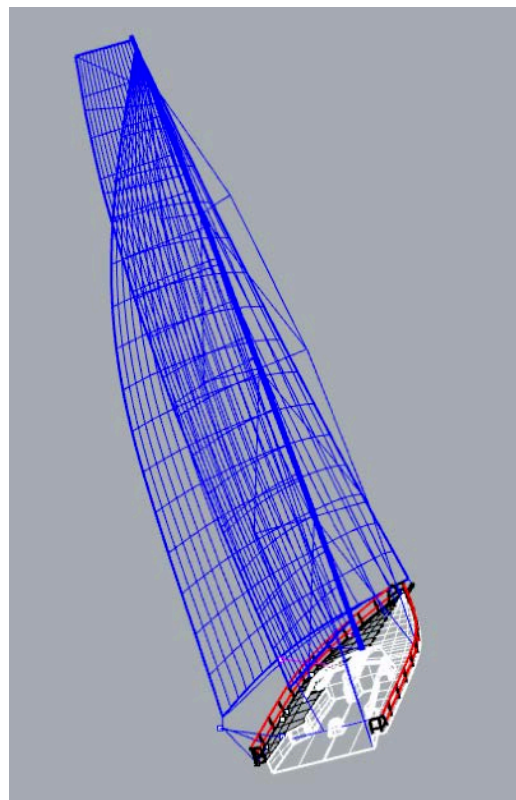
62. All crews were acutely aware of the problem created by the sail plan and the ability to maintain a good lookout on the lee bow⁵. Depending upon which headsails were set there could be an arc of about 90° from the helmsman's position that would be blanked out - from a few degrees on the lee bow to abeam on the lee side. The crews applied themselves diligently to overcome the problem.
63. The A3 Gennaker (A3) and Masthead Code 0 (MH0) cause the most difficulty when running or reaching; being set from the end of the bowsprit, with a low foot and

Figure 5 - A rendering of the sail plan of a VO 65 - with a full main and a MH0 sheeted through the aft outrigger

sheeted well aft nearly adjacent to the helmsman. The use of an outrigger⁶ to sheet the sails further outboard can increase the forward looking blind arc. The situation is further aggravated for a large portion of the time racing, when the boat is being pressed hard on a reach and sailing on a large angle of heel at about 30°; the boom and mainsail can also restrict the line of sight to leeward.

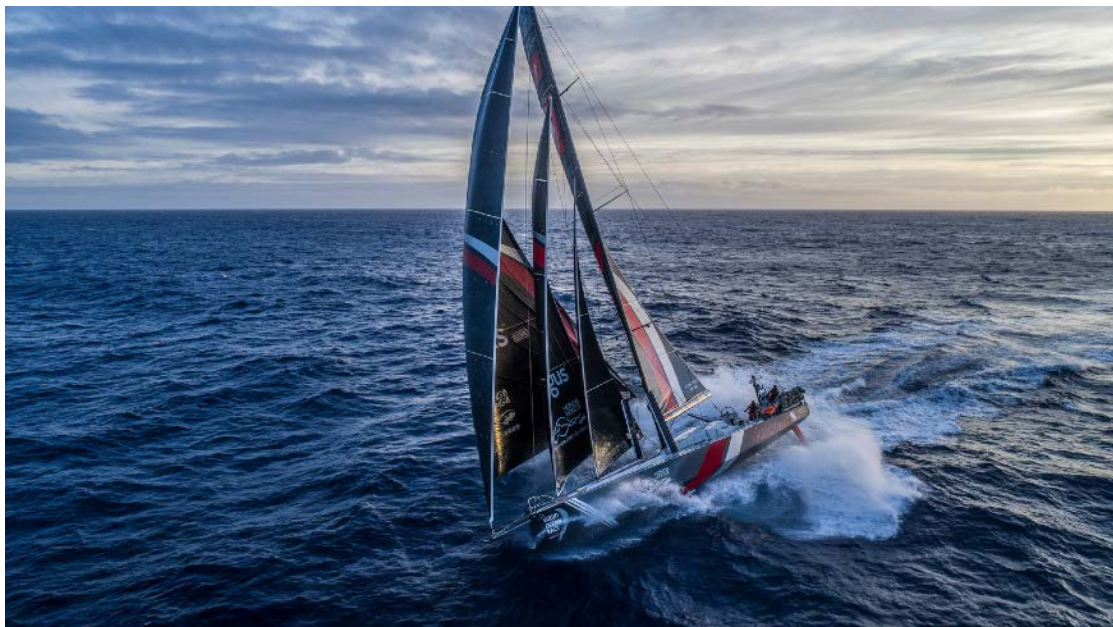
Figure 7 - Sun Hung Kai/Scallywag sailing with a triple headsail rig - MH0, J2 and J3 - the MH0 is sheeted through a outrigger
Credit: Konrad Frost / Volvo Ocean Race

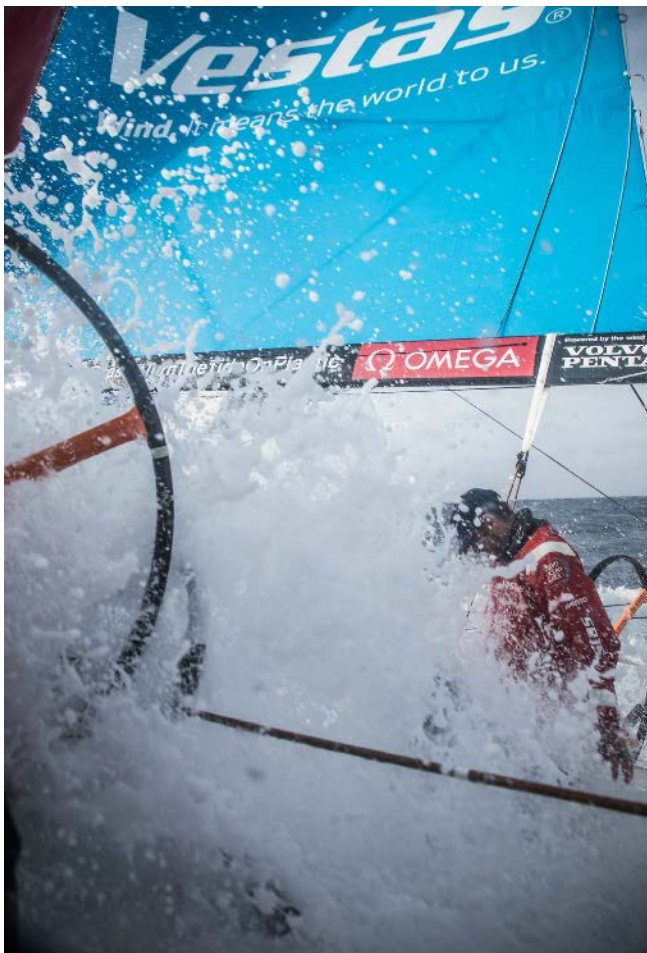
152. Crews need to assess the effectiveness of the look-out and associated risk based on the visibility, the sails set, the level of traffic and speed. In light traffic and good visibility conditions the occasional glimpse to leeward by the trimmer or grinder could be sufficient but may take 30 seconds or longer. In heavier traffic or with limited visibility a dedicated lookout may need to be placed to leeward, if there is not too much spray, or the back lee corner of the boat, to continually try to gain a glimpse forward and to leeward.

153. In some conditions there will be a residual blind arc of about 20°-30° that may be able to be viewed by 'dipping the bow' up to 30° to leeward for the helmsman to gain a view. The dip frequency would need to be adjusted depending on the four

*Figure 17 - The challenge for a leeward look-out
Credit: Martin Keruzore/Volvo Ocean Race*

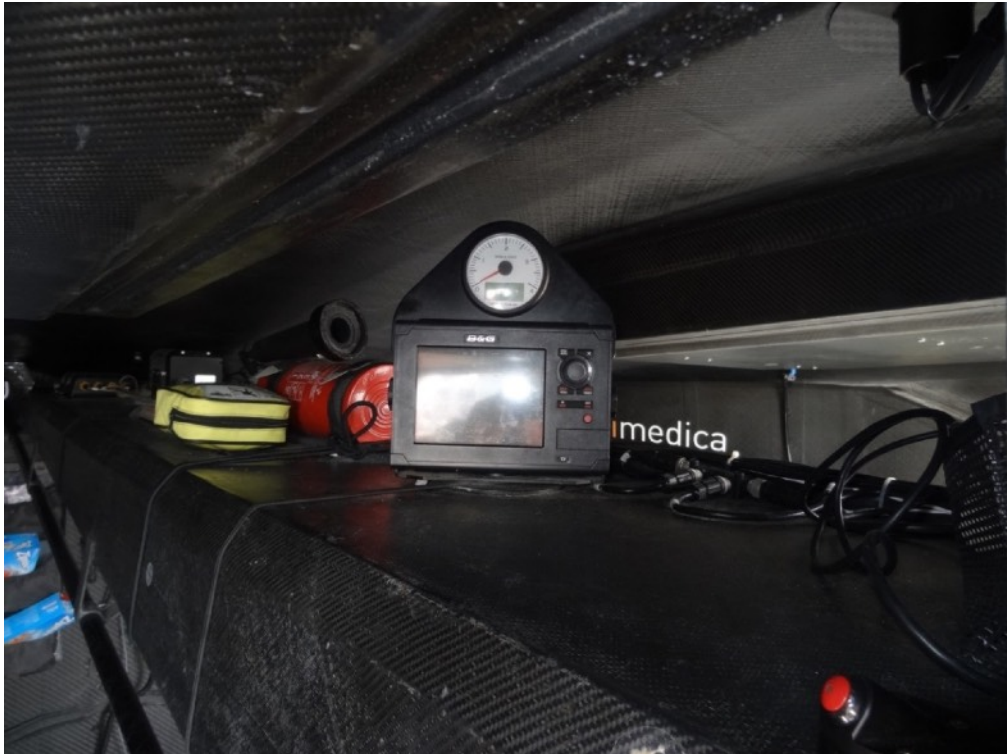
Figure 18 - Photo of the 'tunnel' MFD just inside the cabin available to the crew on deck
Credit: Photo by Chuck Hawley 2014

159. As stated in Section 5 unserviceability and degraded AIS performance have been problems within the VOR fleet. These are believed to be due to the BNC coaxial connector and antenna mounting that is used. BNC coaxial connectors are "quick connect" bayonet fittings. They are neither weather resistant nor vibration proof and are ill-suited for this application where the connector is serving as the physical mount for the VHF antenna.
