Department of  
Transport

## Investigation Report Capsize of the yacht 'Finistere' on 24 February 2018.

Prepared for Department of Transport

Date 12/11/2018

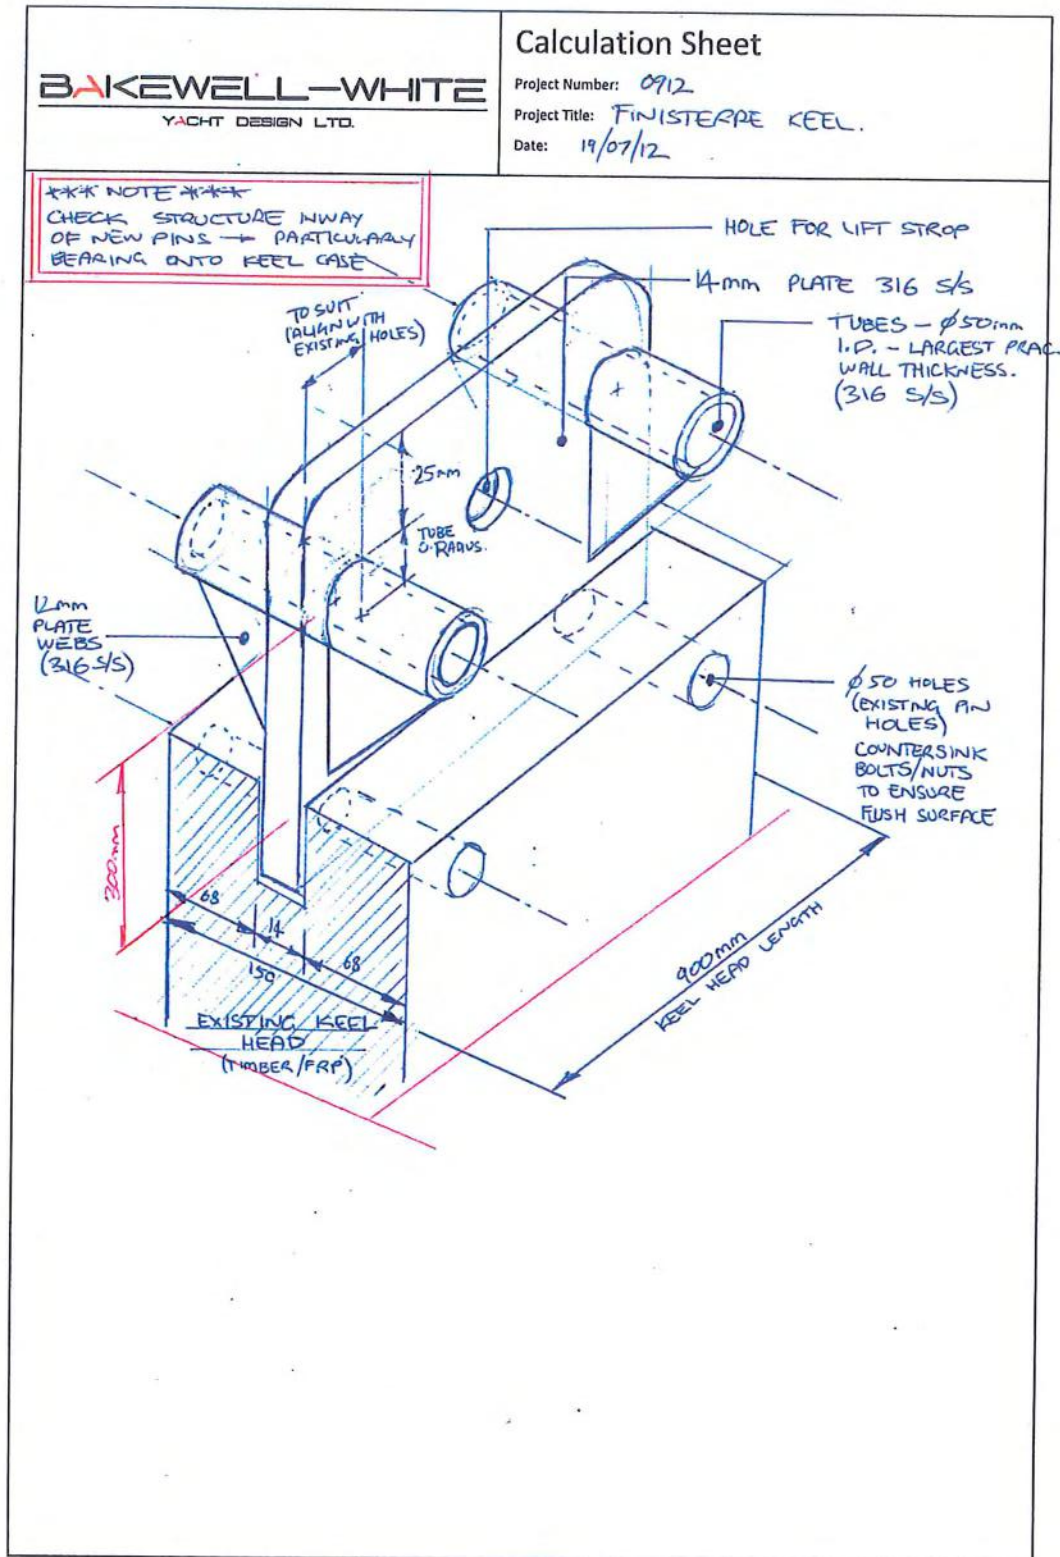
Image 2, Keel modification plans.

Bakewell – White Naval Architect, [REDACTED] proposed another solution in which a steel plate was fitted into the keel. In this version the locking pins are pushed through sleeved holes in the top area of the steel plate, which extends above the original keel. Therefore, the holes through the keel case could now be located above the waterline (see image 2).

[REDACTED] noted that the keel modification drawings contained no details relating to the bonding and sealing arrangements between the steel plate and original keel.<sup>25</sup>

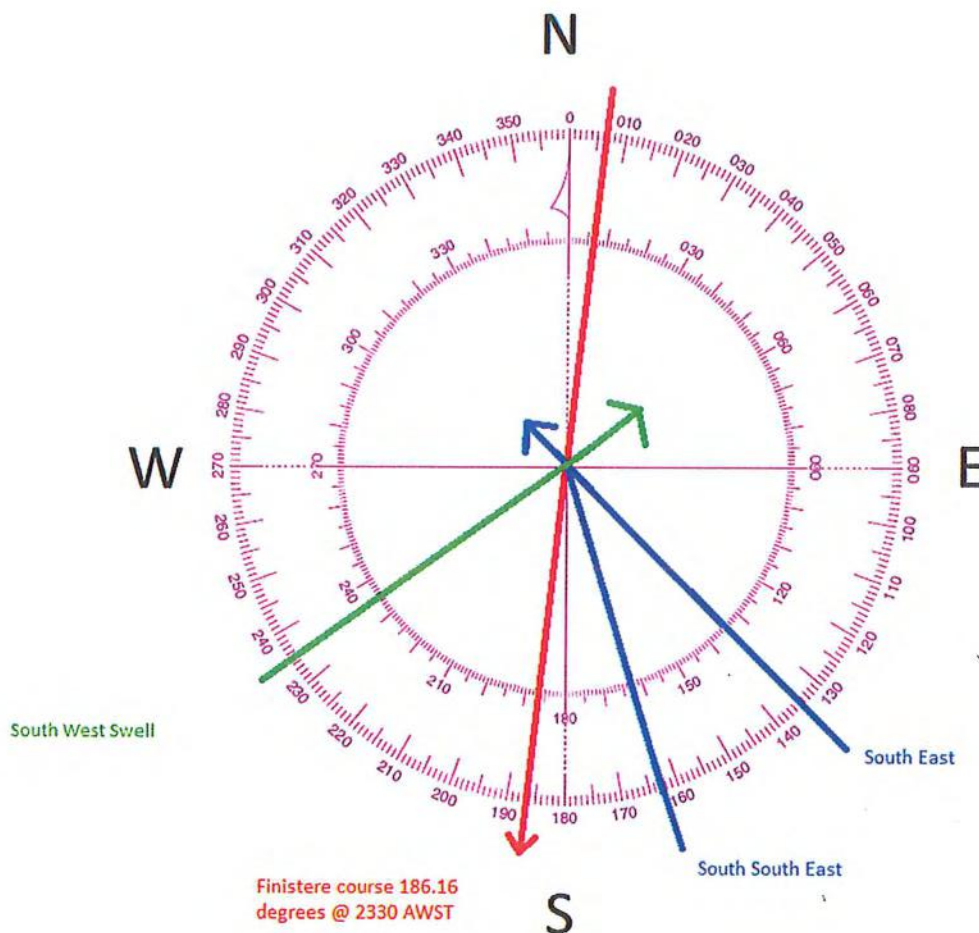
Image 17 Finistere's course and wind direction.

- The vessels last known course was 186.16 degrees at 5.1 knots (23 Feb 2018 ,2330 AWST).
- The wind was S/SE at 25 to 30 knots.
- Seas were S/SE at 2.5 to 3 metres.
- The swell was from the SW at 1 to 1.5 metres.

This meant that with the wind approaching from the port side to forward of the port beam (forward of the centre of the hull) Finistere was heeling to the starboard side. The tendency of the ballasted keel is to resist a heeling moment and return the vessel to an upright position. With the wind on the port side tension increases on the port side and compression on the starboard side. The weakened structure above the shaped foil (within the keel case), under increased tension slipped on the port side and the resulting movement caused the keel to break off at the shaped foil (where the keel enters the hull when it is in the downward position).

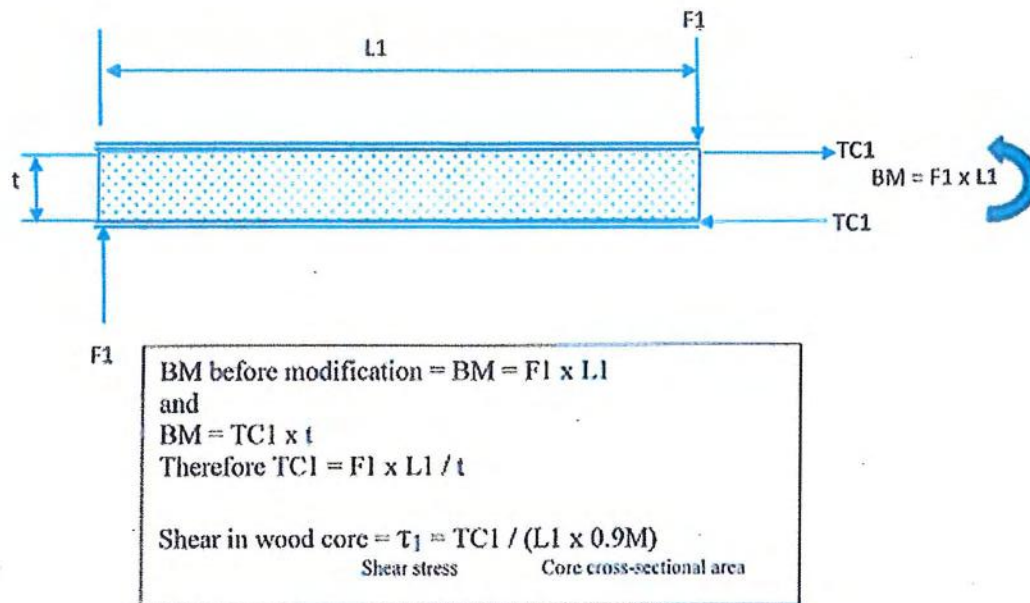
The casing has to apply forces to the keel to counteract that bending moment. Assume the keel within the casing is supported only by reaction forces at the ends (simple, but not pessimistic). Drawing the keel within the case in a horizontal orientation – next page:

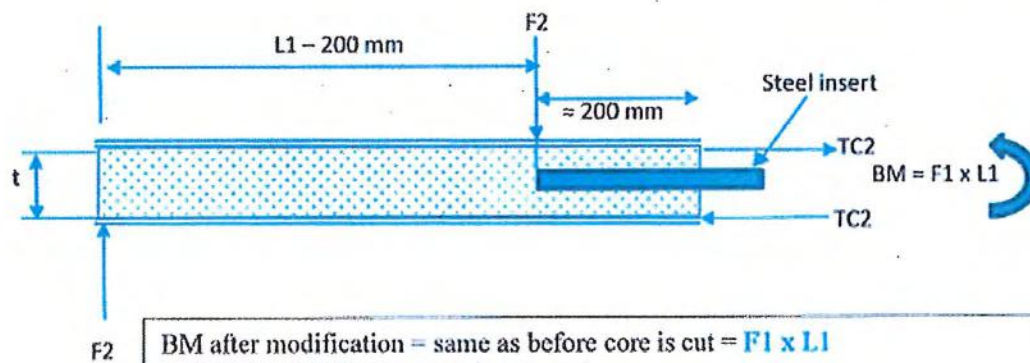
After core is cut to insert steel plate, assuming no shear connection between the steel plate and wood core:

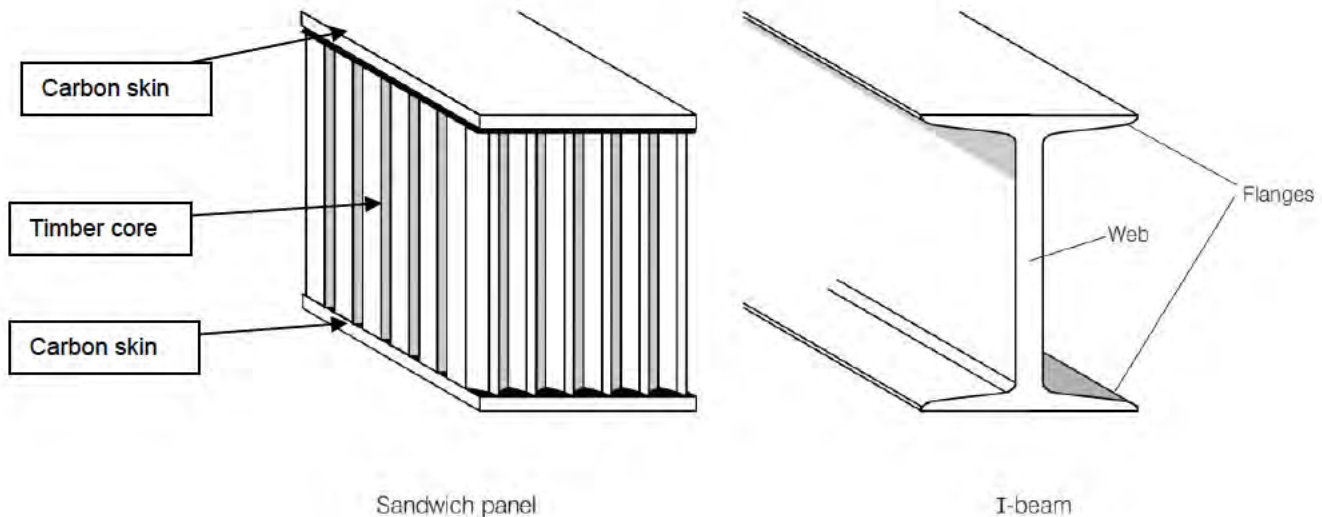
The keel can be considered to be a sandwich construction. There are two carbon fibre skins separated by a timber core. The skins can be compared to the flanges of an I-beam. When the keel is subjected to bending one carbon fibre skin is in compression whilst the other is in tension. This tension and compression are forces that act in opposite directions.

Similarly, the timber core can be compared to the web of the I-beam. The core resists the shear loads and increases the stiffness of the structure by holding the two skins apart. Since one carbon skin acts in tension, and the other in the opposite direction in compression, without a core there would be nothing to stop the two skins moving relative to each other. The shear strength of the core resists the two skins from sliding relative to each other.
